LOWER HOUSATONIC RIVER BASIN
SEYMOUR, CONNECTICUT

PEAT SWAMP RESERVOIR DAM CT 00088

PHASE I INSPECTION REPORT NATIONAL DAM INSPECTION PROGRAM

AUGUST 1978

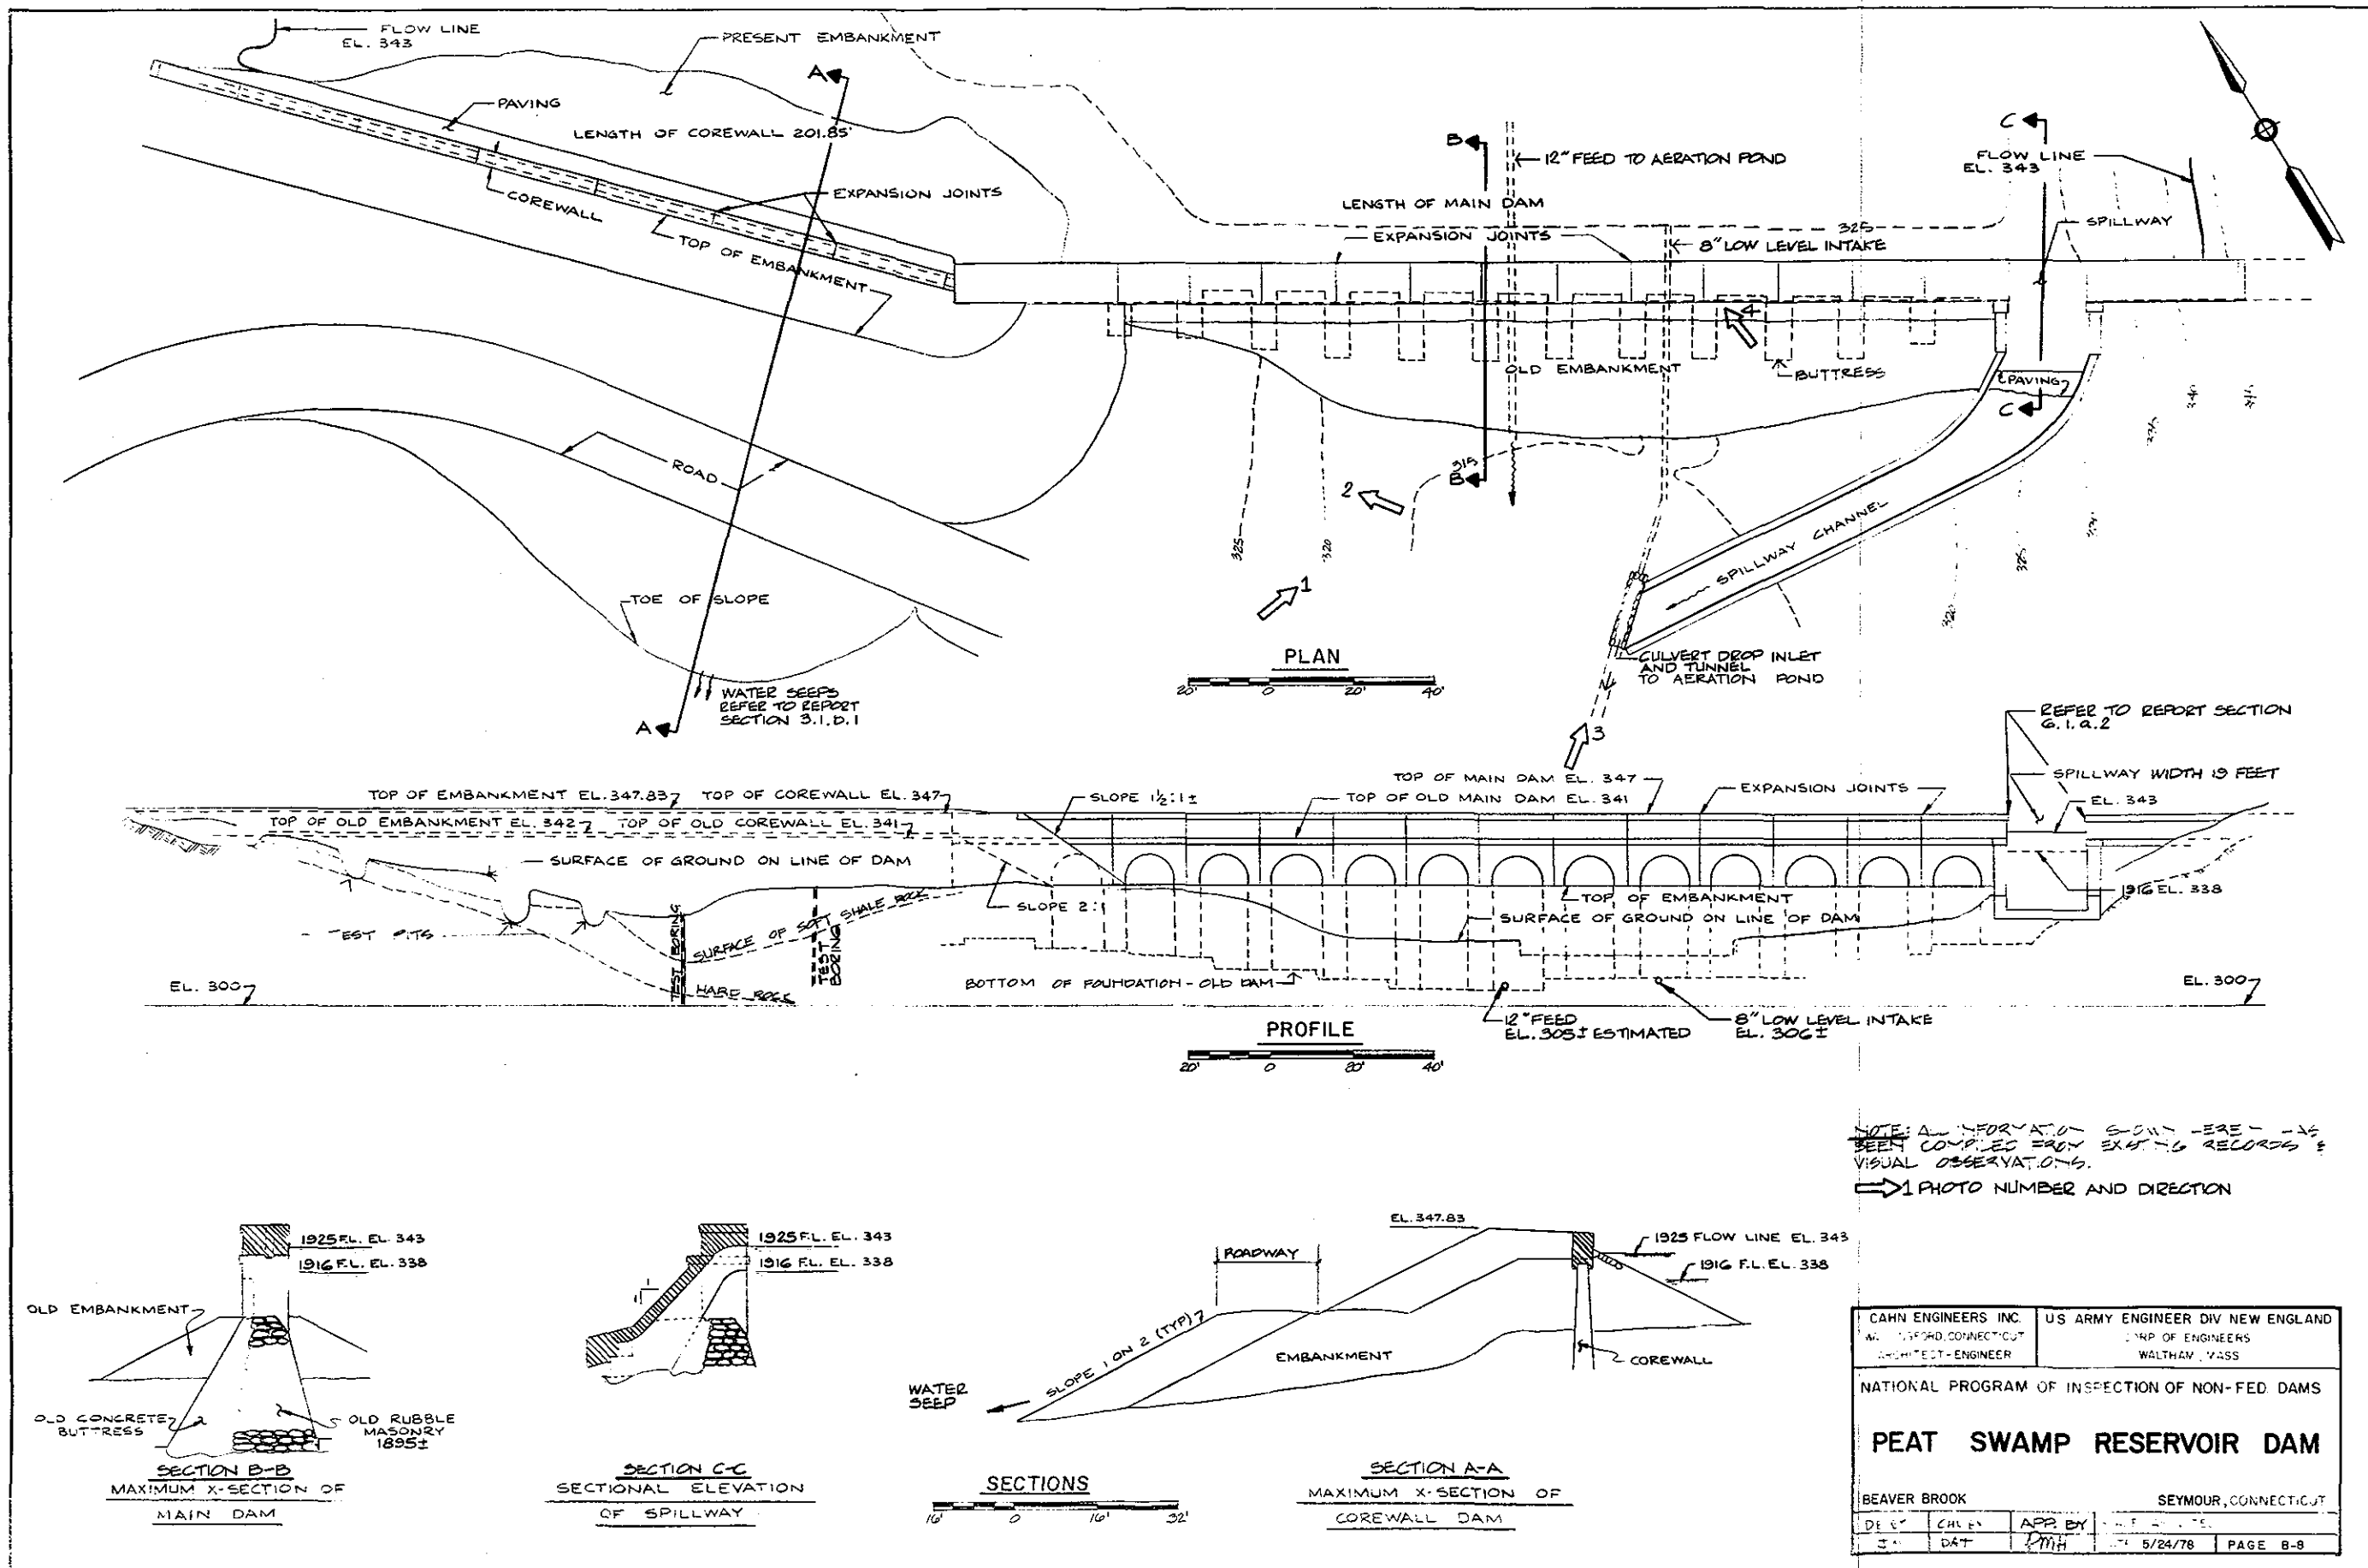
Downstream Berm - The downstream berm is generally in good condition with no sloughing or wet spots noted. There are a few holes made by burrowing animals on the slope and against the concrete wall at the edges of the concrete buttresses. A leak in the concrete wall at the

PHOTO NO.2 - General view of slope of downstream berm of dam section consisting of concrete/rubble wall with earth berms.
